3M ESPE

Making Better Impressions

Trouble

A Troubleshooting Guide

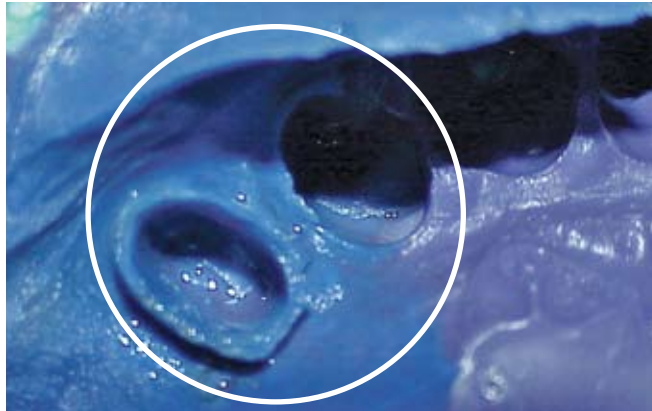
Inhibited Setting

Visual Appearance: Impression not completely set. Shiny, no detail of site.

Result: Inadequate surface detail on stone cast, poor fitting restorations.

Sulfur inhibition due to contact of latex gloves with tissue/tooth/retraction material or impression material.

Residues from custom temporary or provisional cements (acrylics) present.

Wear gloves proven not to contain traces of sulfur.

If contamination is suspected, scrub affected area with diluted hydrogen peroxide.

Do not use impressions already used to fabricate the temporary restoration.

Fabricate the temporary crown or bridge after final impression has been made.

Remove air-inhibited layer on the exposed surface with an alcohol wipe before making final impression.

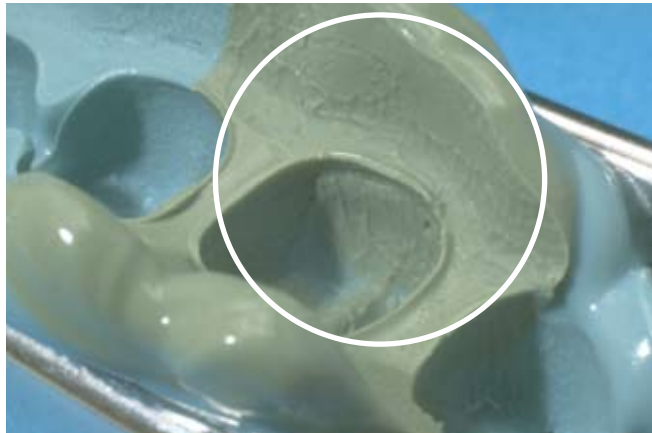
Surface Inhibition

Substances with pH < 4 inhibit setting reaction, most commonly by the contact with acidic retraction materials and hemostatic agents containing epinephrine or ferric sulfates.

Use retraction materials having pH ≥ 4 .

Select retraction materials and hemostatic agents not containing these chemicals.

Rinse, remove, dilute hemostatic solution with water spray and suction. Dry before taking the impression.

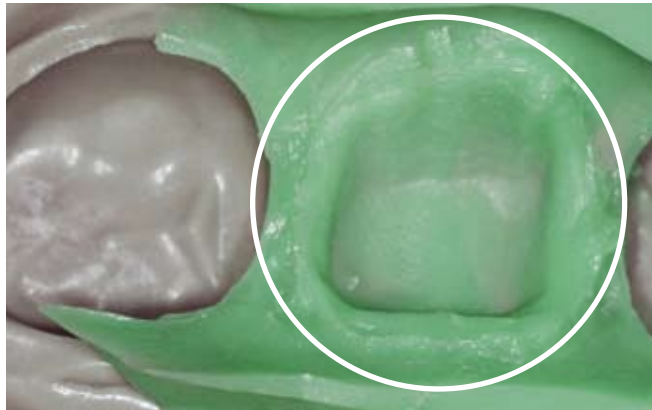
Lack of Impression Detail

Visual Appearance: Muted detail reproduction.

Result: Crowns may be too tight, or loose, and not fit correctly.

CAUSE	SOLUTION
Impression material stored at elevated temperature.	Store impression material at room temperature.
Impression material stored at too low a temperature (prolongs the setting reactions, changes viscosity and requires exceptionally high extrusion forces for automix materials).	Keep impression material at a temperature of 18°C/64°F at least one day prior use.
Thick blood/saliva pooled around prep.	Remove blood and saliva prior to making impression. Use 2-step impression technique.
Inadequate retraction of sulcus around prep.	Use good retraction technique, with proper moisture control.
Exceeding the working time.	Follow manufacturer's working time specifications. Choose material with longer working time.
Inadequate disinfection effects surface quality (detail reproduction) and dimensional stability.	Use water based disinfectants according to FDA guidelines. Follow manufacturer's instructions for use.

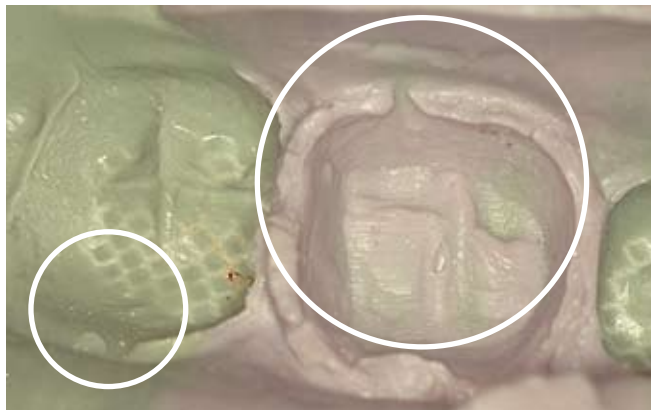
Void Caused by Syringe Technique

Visual Appearance: Voids/holes on margin of the prepared teeth. Incomplete margin.

Result: The fit and function of the final restoration may be compromised. Short crown margins and/or open margins.

CAUSE	SOLUTION
Air trapped in intraoral syringe.	Properly bleed filled elastomer syringe. Keep tip immersed in material when loading syringe. Do not stop when in the middle of loading syringe.
Air trapped while filling impression tray.	Keep mix tip immersed in tray material while filling the tray.
Improper syringe technique.	Keep syringe tip immersed in wash material to avoid entrapping air. Wiggle and stir while syringing. Push material forward.
Inadequate coverage of marginal area with light body impression material.	Use wash material liberally on preparation and abutments.

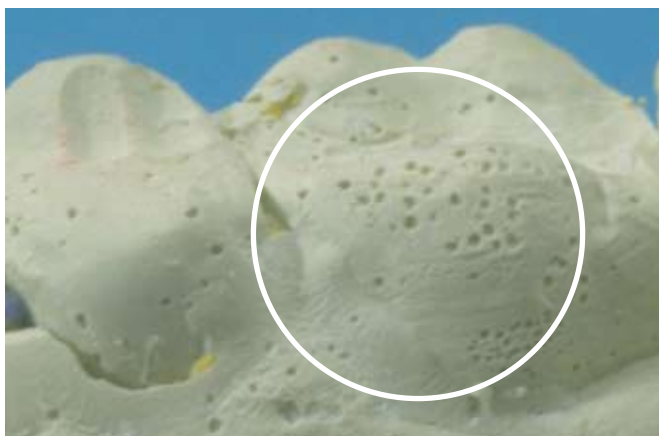
Stone Model with Hydrogen Evolution Voids

Visual Appearance: Voids on margin, powdery cusp tips on incisal edges on prepared tooth. “Golf-ball” appearance of stone model.

Hydrogen gas emission.

Follow manufacturer’s instruction for casting time.

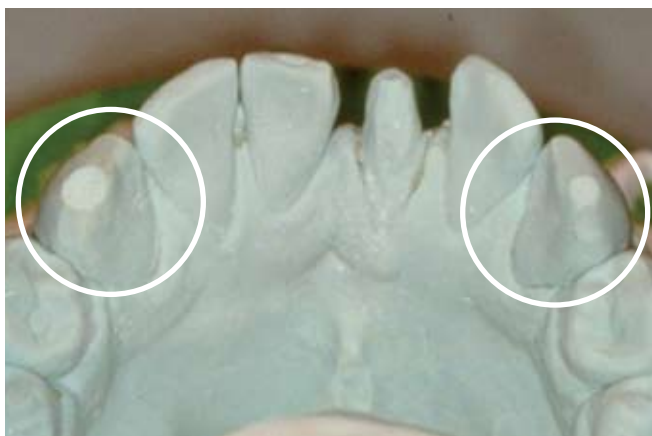
Stone Model with Powdery Cusp Tips

Tooth contact with impression tray, or gauze of double bite tray causes water to leach out of the tray, dehydrating the stone.

Instruct patient to bite passively in centric occlusion when using dual arch trays.

Fill tray with sufficient amount of material.
