3M ESPE

Making Better Impressions

Trouble

Shooting

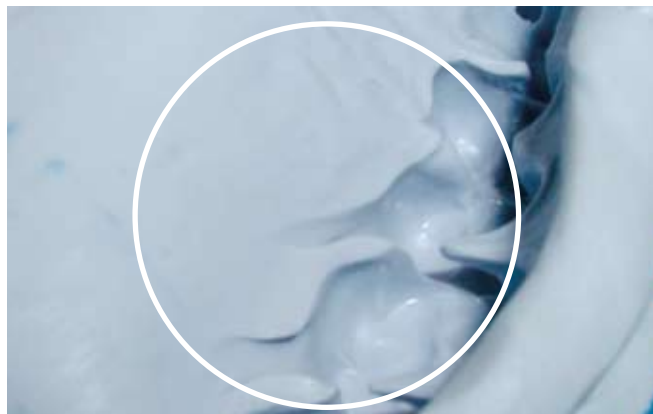
Lingual Pulls

Visual Appearance: V-shaped void, trough-like.

Result: Failure to capture complete and accurate dentition.

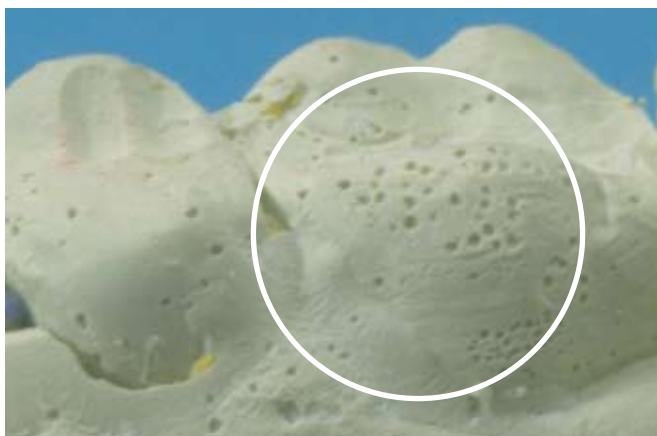
Stone Model with Hydrogen Evolution Voids

Hydrogen gas emission.

Follow manufacturer’s instruction for casting time.

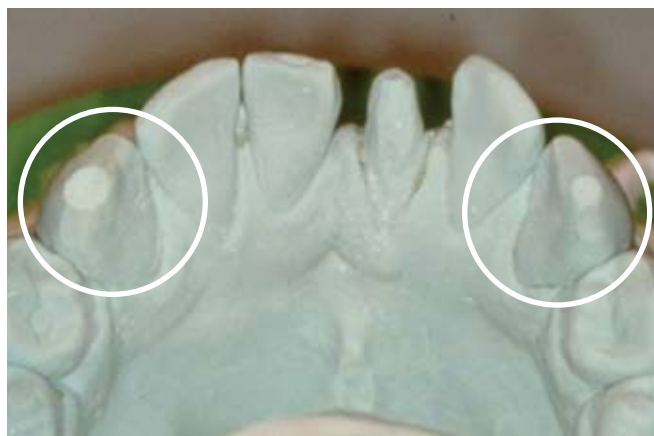
Stone Model with Powdery Cusp Tips

Visual Appearance: Voids on margin, powdery cusp tips on incisal edges on prepared tooth. “Golf-ball” appearance of stone model.

Result: Incomplete seating of indirect restorations.

Tooth contact with impression tray, or gauze of double bite tray causes water to leach out of the tray, dehydrating the stone.

Instruct patient to bite passively in centric occlusion when using dual arch trays.

Fill tray with sufficient amount of material.
